Manhole Inspection Summary

Manhole # S17GG1002MH

Insp Date: **1/8/07 1:44 PM**

Location Address: **4026 GREENSPRING AVE**

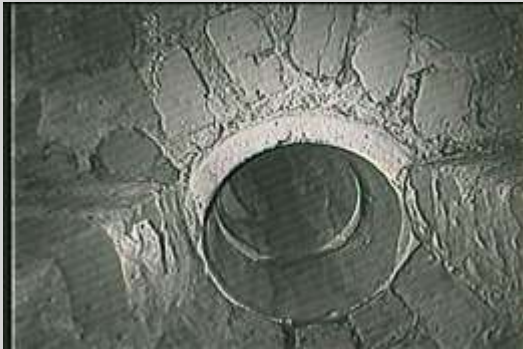
8 in. Circular Gravity Sewer Pipe Out @ 12 O'Clock

Invert Depth: **12.82** (ft.) Flow Characteristics: **Slow**

Deposits: ☒ None ☐ Mud ☐ Sludge ☐ Debris ☐ Grease

Infiltration: **None** Pipe Seal Cond: **Unknown**

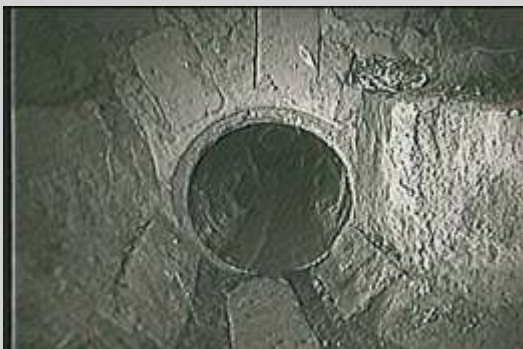
6 in. Circular Gravity Sewer Pipe In @ 9 O'Clock

Infiltration: **None** Pipe Seal Cond: **Unknown**
